18 February 2022

## **ACCESSIBILITY REPORT Dimond Park Oakland**

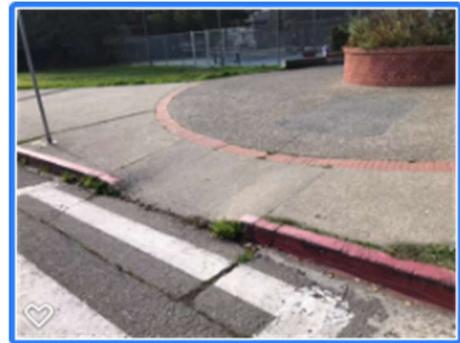
The park was entered from Fruitvale Avenue at Lyman Road. There are crosswalks and curb ramps at the corners, but they are not in compliance with current code. They are too steep and do not have the yellow detectable warning that is required where a path or sidewalk meets the street. I would recommend at least one designated accessible parking stall with direct access to a code-compliant curb ramp.

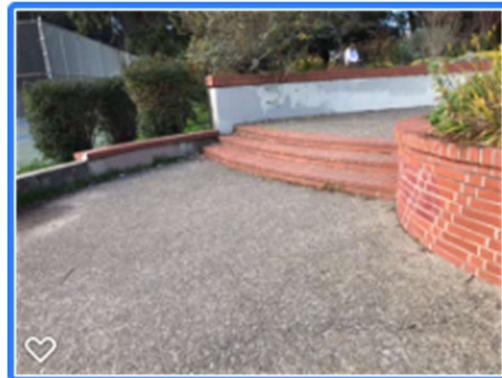
This entrance has planters with brick borders and steps that are inaccessible to people in wheelchairs. This is an attractive feature inviting people into the park. The goal of Universal Design is to welcome everyone with an equal experience. A new accessible entrance should incorporate brick detailing or in some way provide an inviting experience.

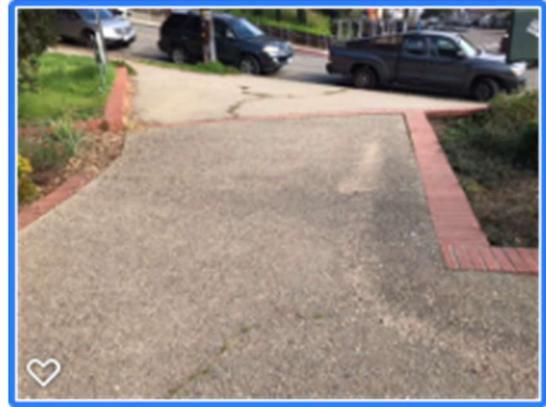
The slope of the sidewalk at the natural grade in this area is too steep for a person in a manual wheelchair. A person in a motorized wheelchair could probably navigate it or if someone were pushing them, they could enter the park uphill (to the north) where a path without steps connects the sidewalk to the paved path in the park.

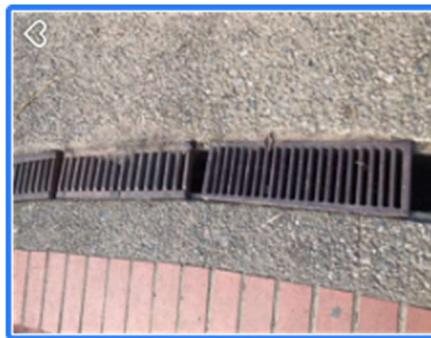
I noticed huge gaps in the trench drains. Wheelchair wheels can't negotiate this, but it is at the top of steps, so probably not an issue for people in wheelchairs. This would be a hazard for many able-bodied people, who could catch a heel or small shoe in the gap.

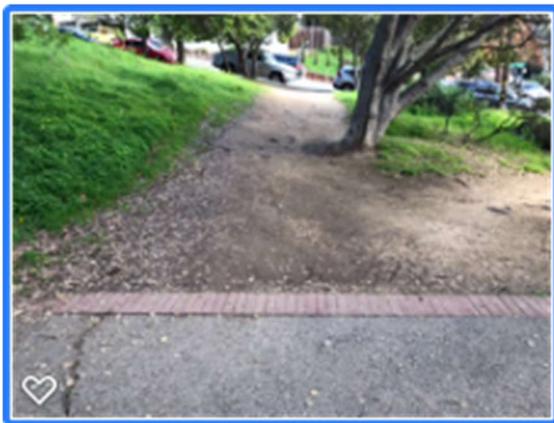
Many of the paths in the park are tamped earth or bark. These are not wheelchair accessible. Every amenity should at least allow a person with mobility issues to get to the facility. The benches near the Scout Hut are over bark. At least one bench should be accessible with a firm stable surface connected to an accessible path of travel. There is a paved path to the playground area, but then there is a concrete curb between the play structure and the area with the benches that had a 2" drop to the bark. That is a barrier to wheelchairs. The maximum level change is 1/2".

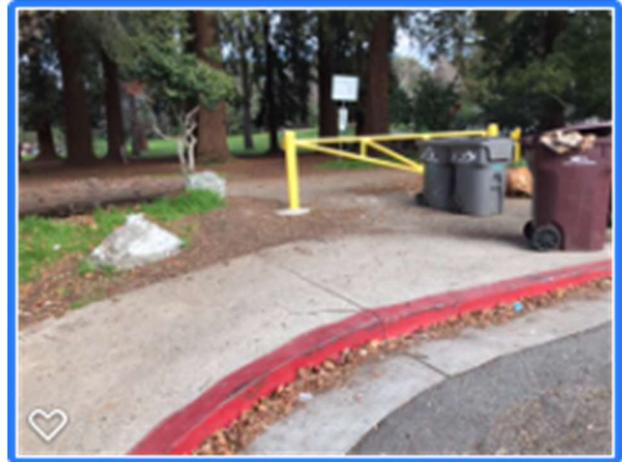
There is another playground near the end of Dimond Avenue. It has a paved path that is an accessible route that leads to a portion of the play structure, but there is no way for a person in a wheelchair to get to the path. There should be a curb ramp in the sidewalk and a paved walkway to connect to the existing path. I would also recommend at least one designated accessible parking stall at the top of Dimond.
