9/8/2016

Dimond Park Pathways Accessibility Evaluation

Prepared for: The City of Oakland, ADA Programs Division

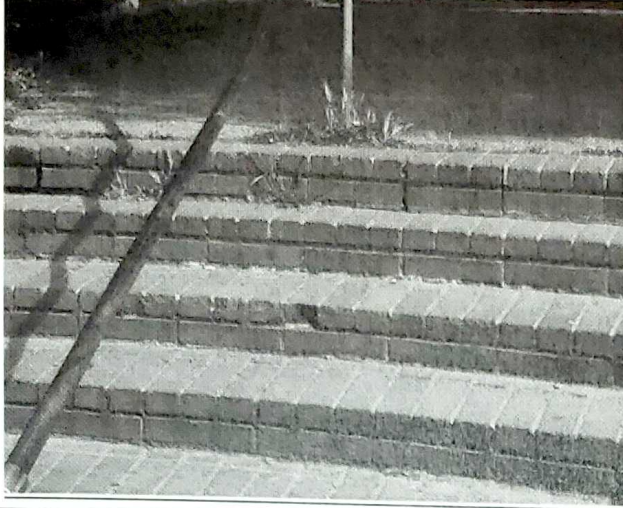
1. Stair treads need to be reconstructed.

- A. Several of the existing red brick stair treads that require repairs. These stair treads need to be reconstructed. See photo #1.
- B. The stairs need to have handrails installed at the center of each stair case. See photos #2 and #3.

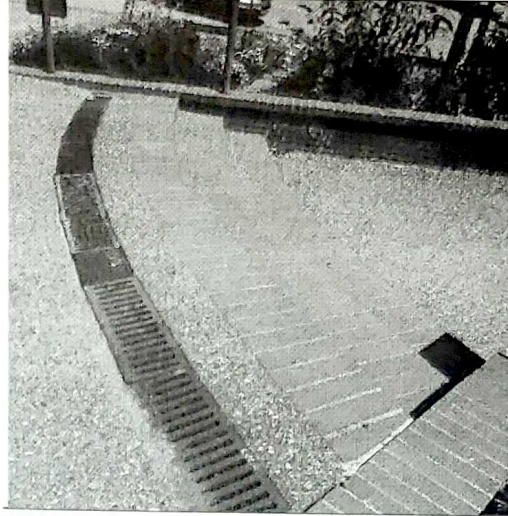
2. Edge of stair treads need contrasting color.

- C. The edge of each stair tread needs to be delineated with a contrasting color. See photo #2.
- D. The trench drain grates in the vicinity of the stairs need to be replaced with ADA compliant grates. See photos #2 and #5.

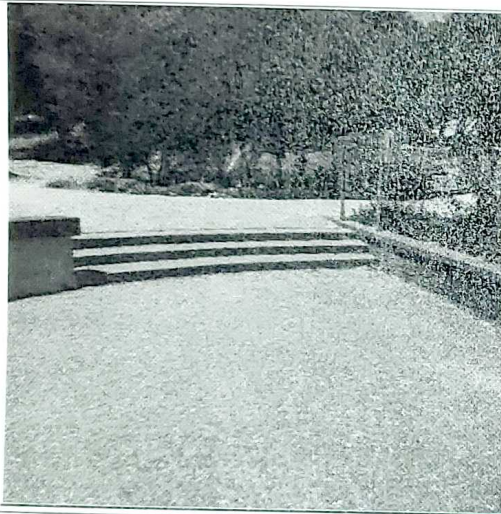
3. Stairs need to have handrails installed.

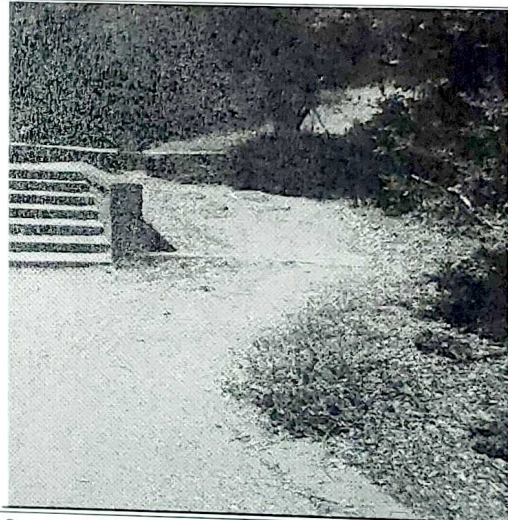
4. Accommodate bicyclists that wish to bypass the stairs.

- E. Improvements should be made to accommodate bicyclists that wish to bypass the stairs. A new compacted gravel pathway should be constructed northerly of the stairs. See photo #4.

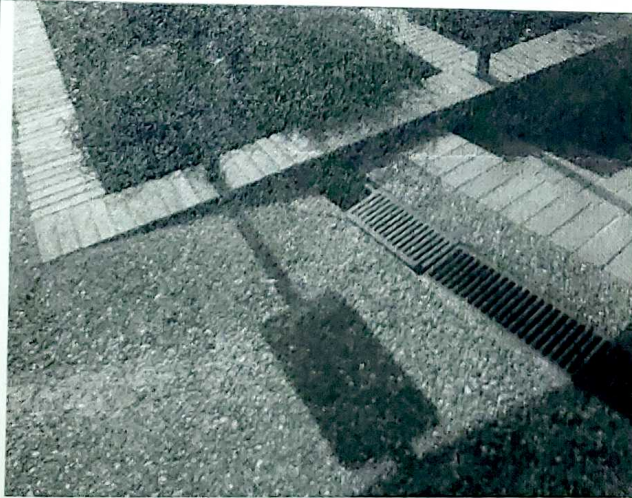
5. Retrofit drainage with ADA compliant grates.

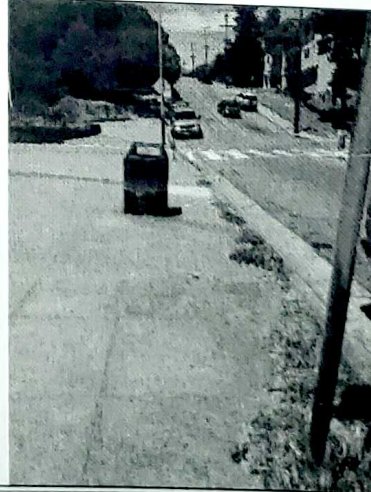
6. Install new passenger loading and unloading zone.

- F. A new passenger loading and unloading zone (painted white curb and signage) should be installed just south of the Fruitvale Avenue/Lyman Road intersection. The existing AC Transit bus stop and trash can should also be relocated southerly. Note that the AC Transit bus stop is out of service. Communication with AC Transit is needed to determine if this out of service is short-term. See photo #6.

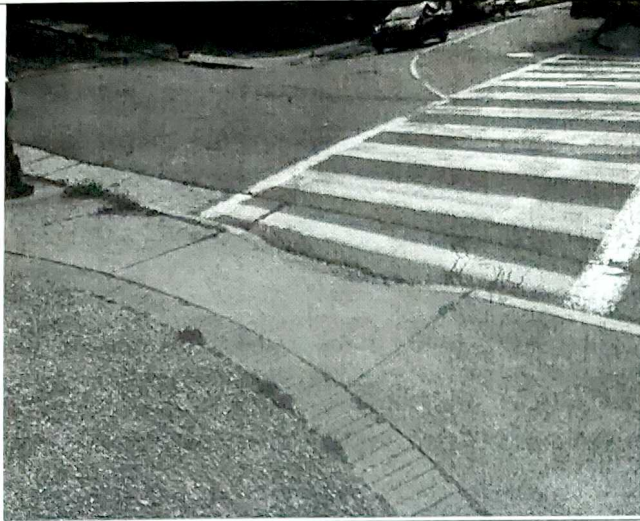
7. Curb ramp at Dimond Park East Entrance.

- G. The curb ramps at the intersection of Fruitvale Avenue and Lyman Road should be field surveyed and modified to be in compliance with current curb ramp requirements. See photos #7, #8, #9 and #10.

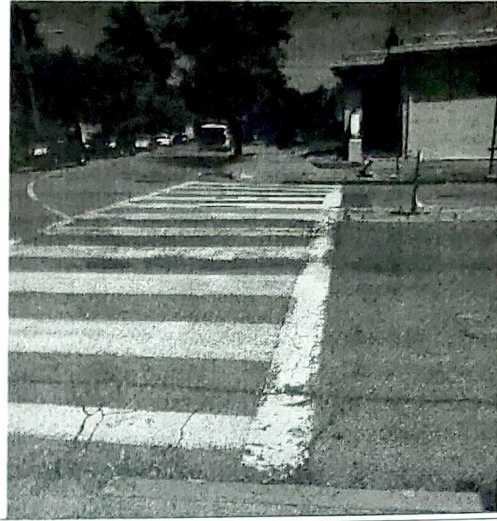
8. Crossing at Fruitvale.

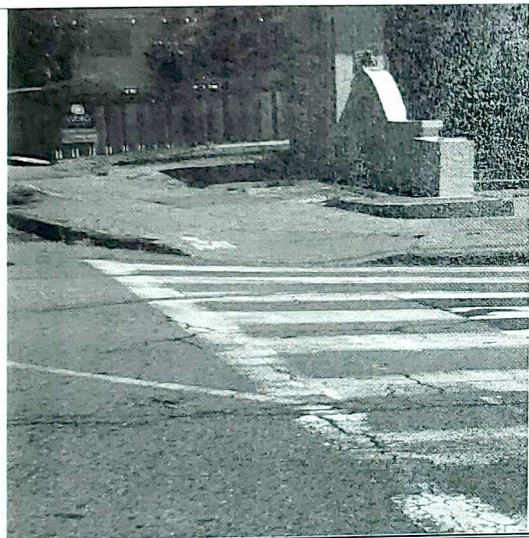
9. Curb ramp at NE corner of Fruitvale/Lyman.

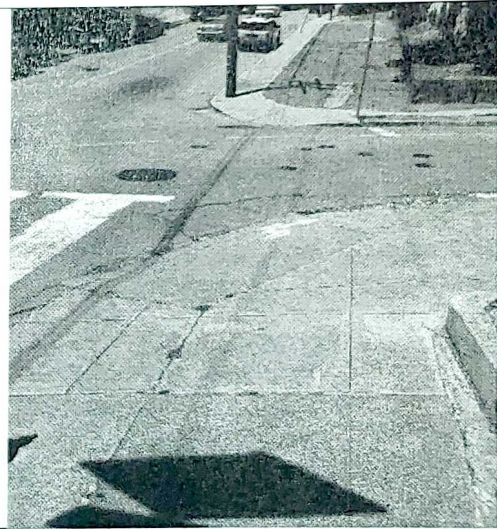
10. Curb ramps at Fruitvale/Lyman.

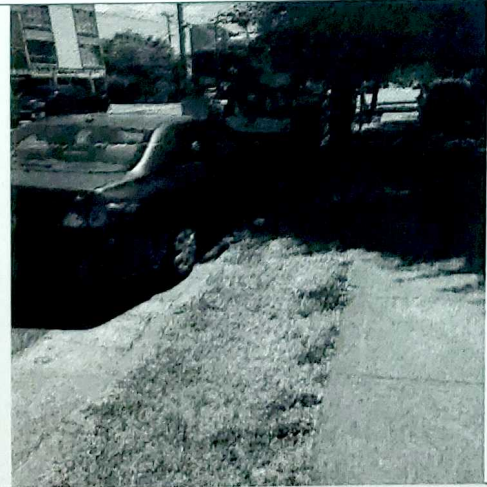
11. One disabled parking stall should be installed on Fruitvale Avenue in SW corner.

- H. A new Disabled Parking stall should be installed (painted blue curb and signage) on Fruitvale Avenue, adjacent to the most southeasterly corner of Dimond Park. See photos #11 and #12.

- I. A new mid-block curb ramp will also need to be installed adjacent to the above noted Disabled Parking stall. See photos #11 and #12.
- J. A new concrete sidewalk should be installed along the southerly limit of Dimond Park, between Fruitvale Avenue and Dimond Avenue. This new sidewalk should reconstruct curb ramp access from the sidewalk into the tennis court area. This new sidewalk should be installed with proper root trimming, root barriers, drainage inlets and tree branch trimming. See Exhibit B and photos #13, #14, #15, #16, #17 and #18.

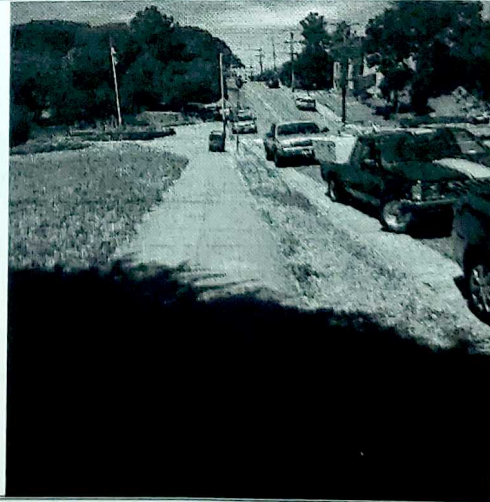
12. One disabled parking stall should be installed on Fruitvale in SW corner.

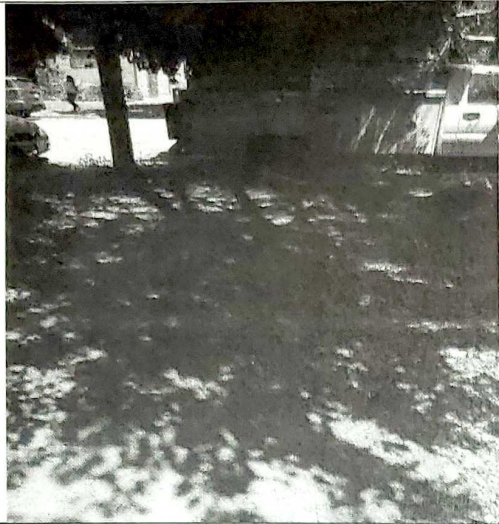
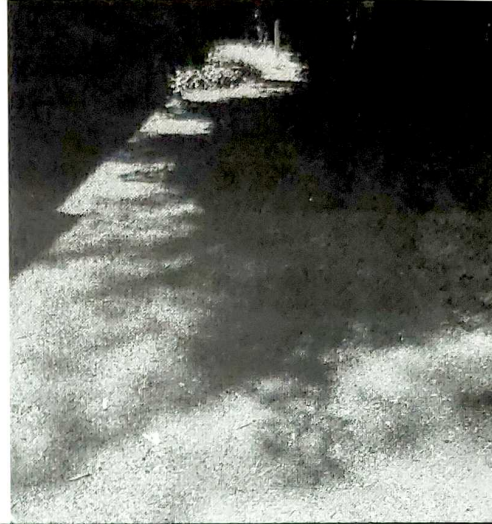
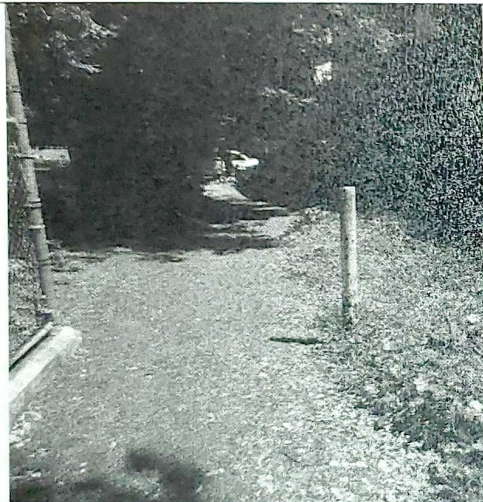
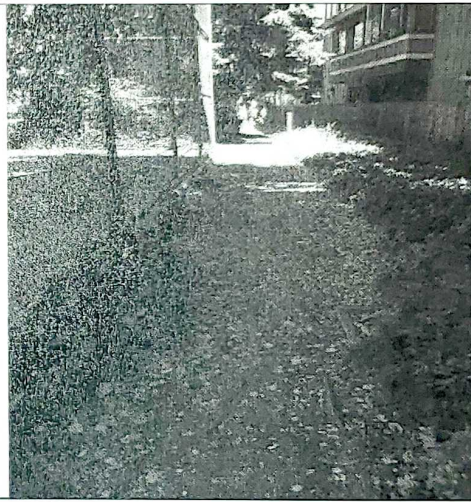
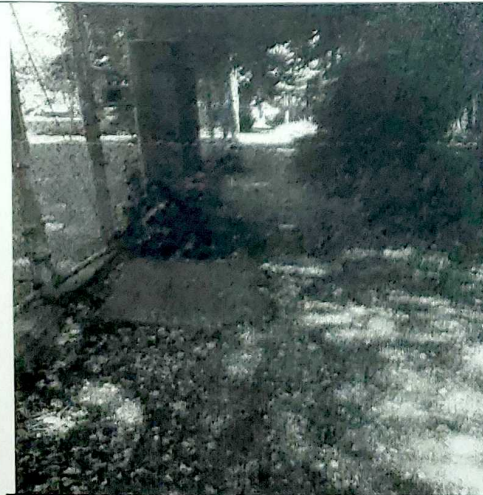
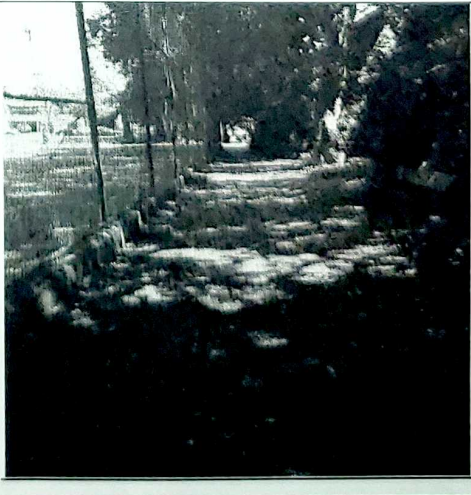
13. New sidewalk along SW corner of Dimond Park.

14. New sidewalk along SW corner of Dimond Park.

15. New sidewalk along SW corner of Dimond Park.

16. New sidewalk along SW corner of Dimond Park.

17. New sidewalk along SW corner of Dimond Park.

18. New sidewalk along SW corner of Dimond Park.

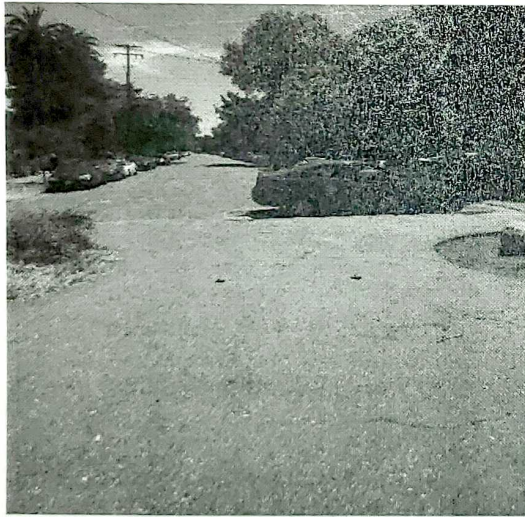
19. Terminus of Dimond Road at South Entrance of Dimond Park.

1. AC Transit operates several bus routes along and in the vicinity of MacArthur Boulevard. Access routes from nearby bus stops to Dimond Park need to be evaluated. Curb ramps at the intersection of Dimond Avenue and Mac Arthur Boulevard should be field surveyed and modified to be in compliance with current curb ramp requirements. The sidewalks along Dimond Avenue from MacArthur Boulevard to the southerly park entrance require spot repairs to eliminate excessive sidewalk joint differentials and sidewalk damage. Root trimming, root barriers and tree trimming should also be incorporated into the sidewalk repairs. See Exhibit A, Exhibit B and photos #19 and #20.

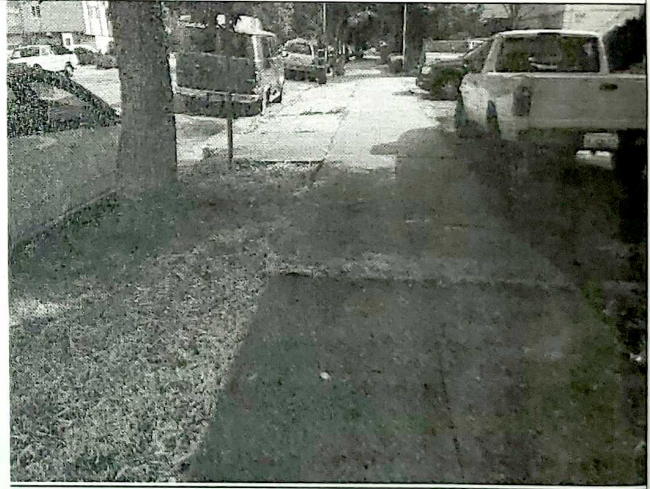
20. Sidewalk repairs are needed along Dimond Road.

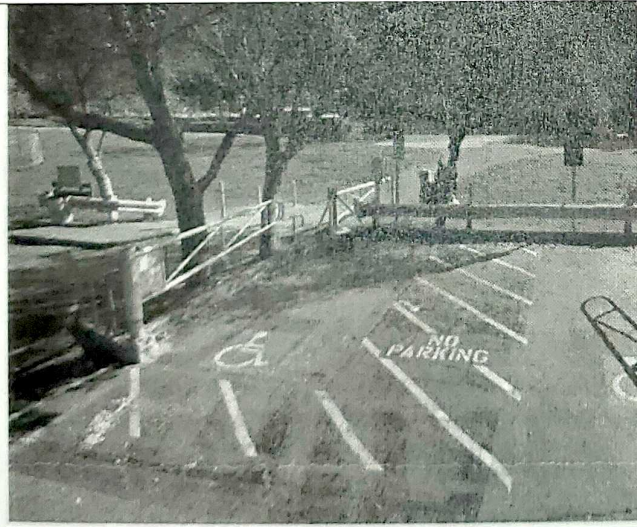
21. Existing disabled parking stalls at west entrance of Dimond Park.

1. The City ADA Coordinator and Dimond Recreation Center Director reported that community stakeholders have requested that two of the existing general 90-degree parking stalls be converted to Disabled Parking stalls. See photo #23.
2. It appears additional roadway and/or ramp improvements are needed to accommodate persons with disabilities. Field surveys should be performed to evaluate the accessible route to/from the Disables Parking stalls to/from Dimond Park. See photos #21 and #22.
3. Disabled Parking stall pavement markings, striping and signage should be evaluated to ensure compliance with existing requirements. At a minimum, pavement markings should be reapplied. See photos #21, #22 and #23.

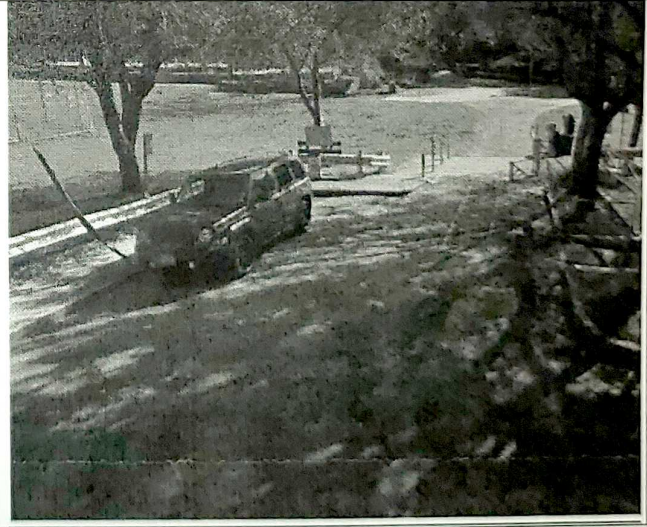
22. Maintenance access gate at west entrance to Dimond Park.

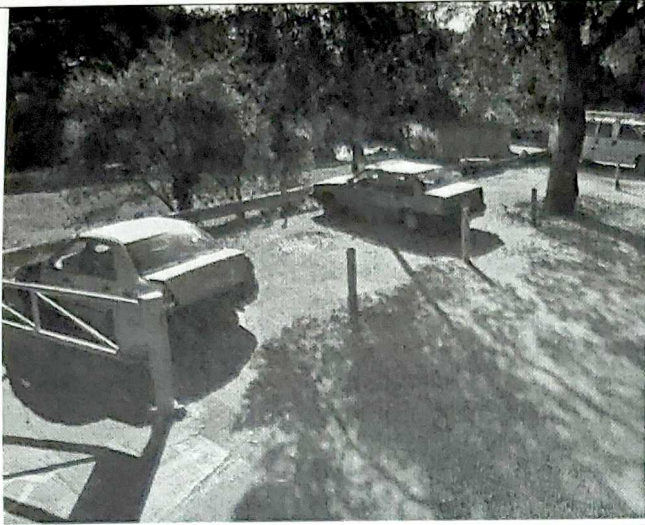
23. Existing 90-degree general parking at West entrance of Dimond Park.

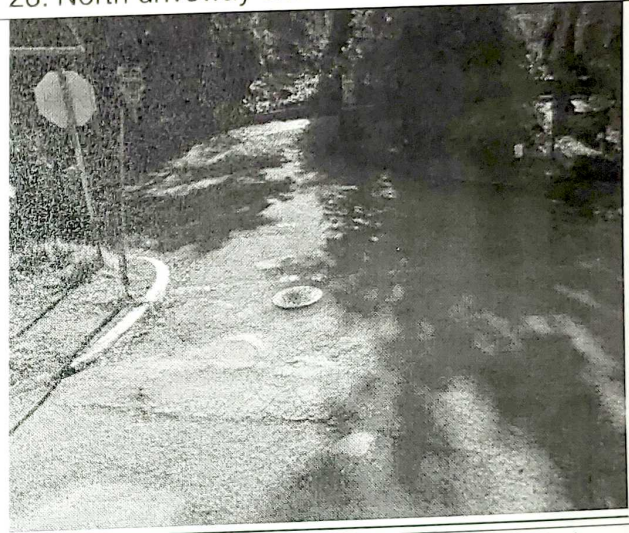
28. North driveway entrance of Dimond Park.

1. Paint a pedestrian pathway along the existing access road. See photos #28 and #30.
2. Paint and evaluate the addition of signage to properly delineate the pedestrian loading and unloading zone immediately adjacent to the recreation center upper level entrance. See photos #31, #32 and #33.
3. Perform pavement repairs and/or roadway reconstruction to reestablish two standard parallel Disabled Parking stalls. See photo #29.

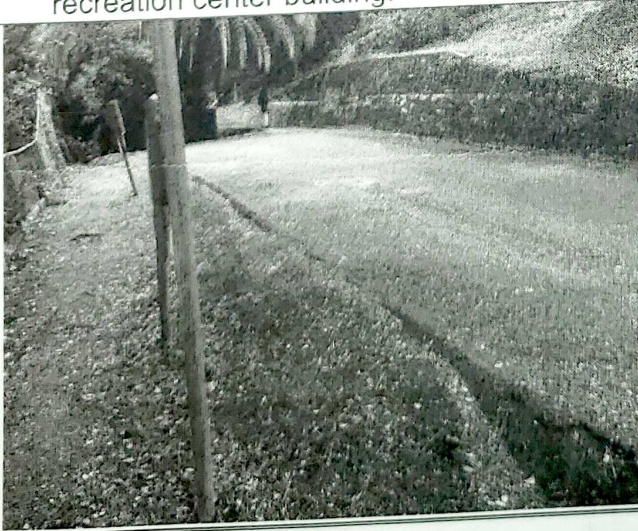
29. Existing disabled parking adjacent to recreation center building.

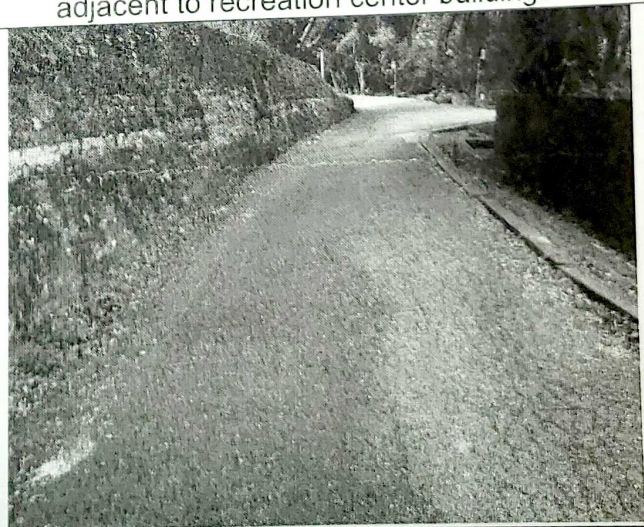
30. Existing disabled parking (distance right) adjacent to recreation center building.

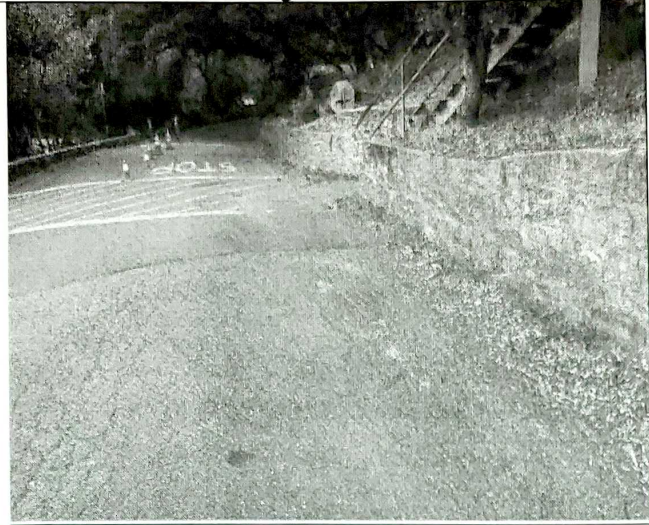
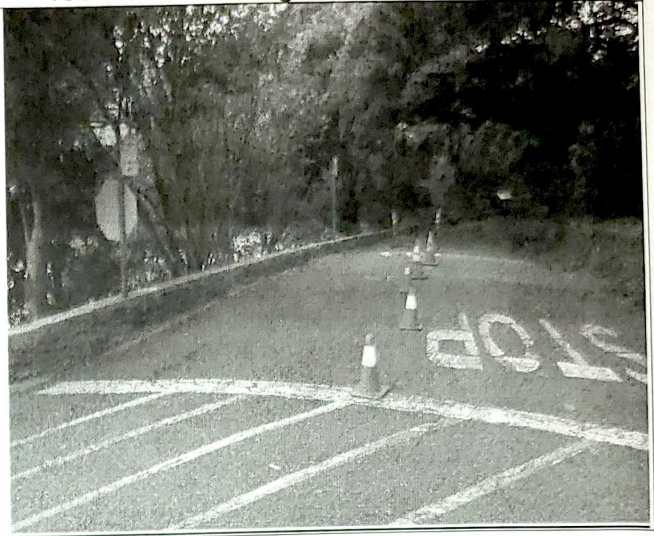
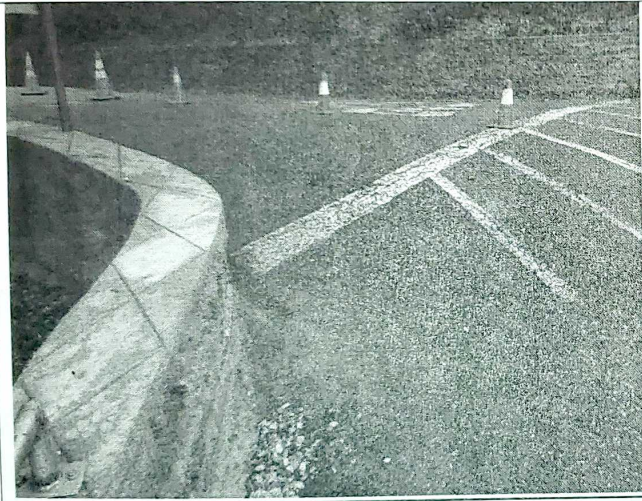
31. Loading and unloading zone in front of recreation building.

32. Loading and unloading zone in front of recreation building.

33. Loading and unloading in front of recreation building.

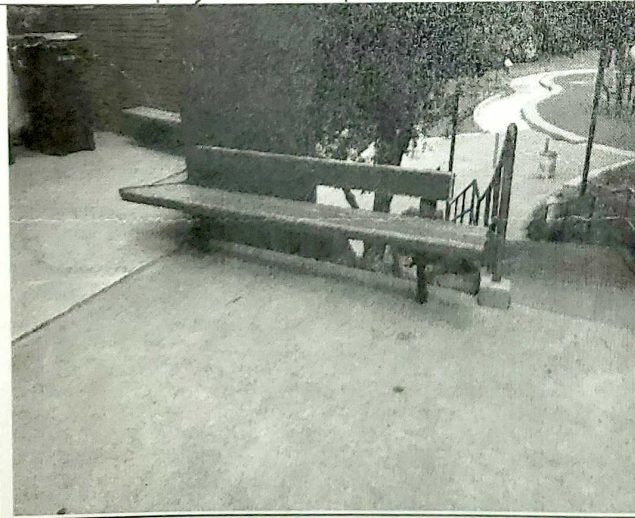
35. Staircase adjacent to recreation center to access play area and pool.

1. Install an elevator within or adjacent to the Recreation Center. This will accommodate persons with disabilities to access both levels of the Recreation Center. See photo #35 for possible location of elevator.

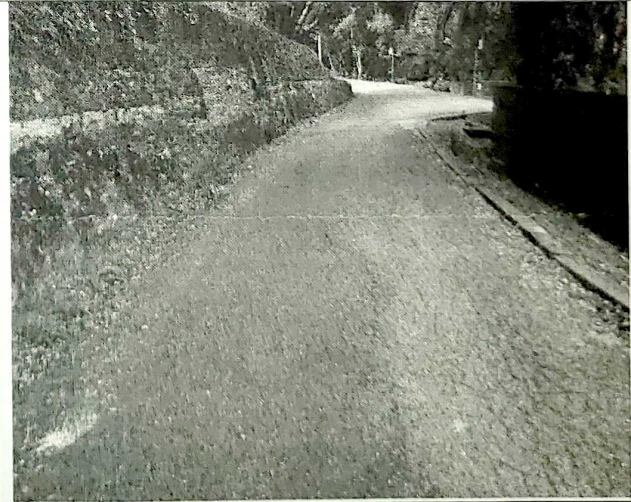
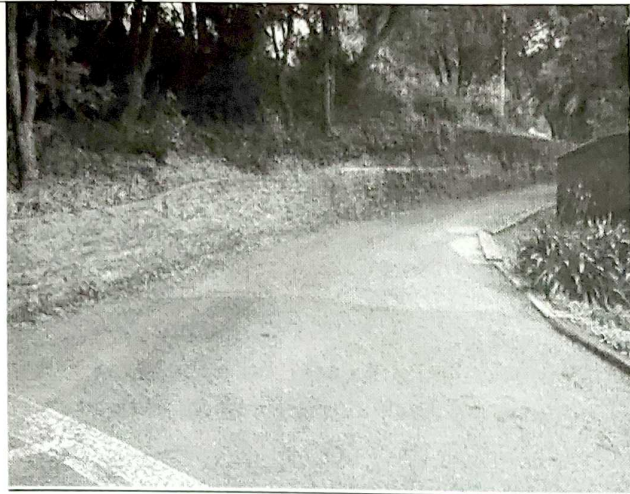
36. Vehicle access road connecting disabled parking to front entrance of rec center.

37. Vehicle access road connecting disabled parking to front entrance of rec center.

2. Paint an accessibility pathway on the existing pavement between the two parallel Disabled Parking stalls and the entrance to the upper level of the Recreation Center. See photos #36 and #37.

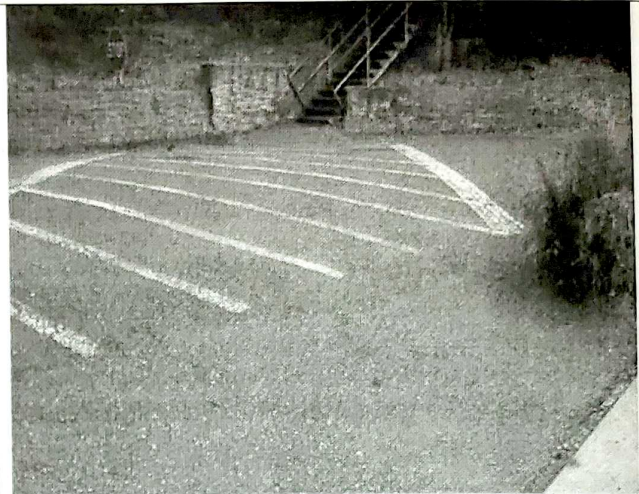
38. Staircase connecting upper parking lot to front of recreation center.

3. The staircase connecting the upper parking lot to the recreation center building should be evaluated for additional improvements. In particular, the edge of each stair tread needs to be delineated with a contrasting color. Additional hand rails should be installed at the top and bottom of the staircase. See photo #38.

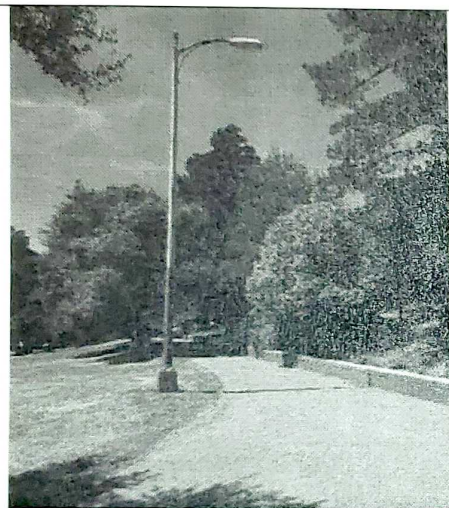
39. Light standard within Dimond Park.

4. The existing lights within the park should be evaluated for proper illumination dusk to dawn, and these lights should be converted to LED bulbs. See photo #39.

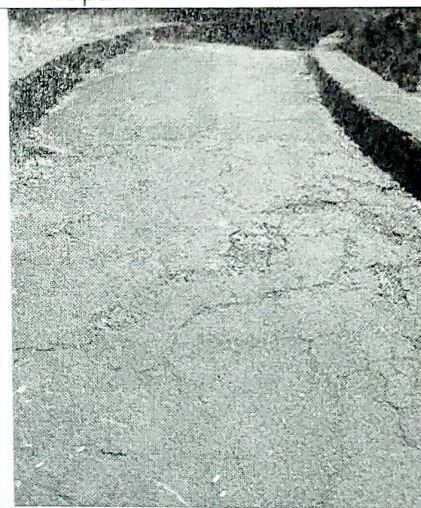
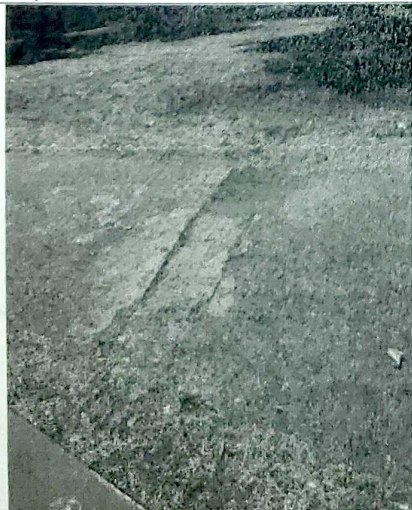
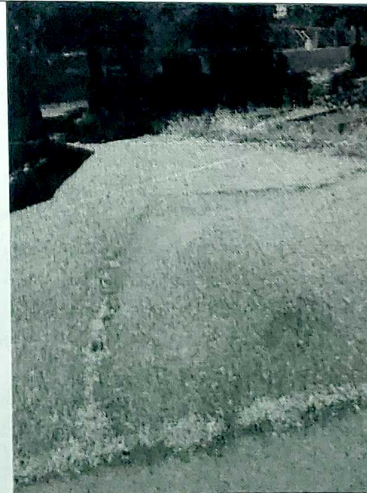
40. Existing pathway pavement is in need of repair.

41. Existing pathway pavement is in need of repair.

42. Existing pathway pavement is in need of repair.

7. There are several locations throughout the interior sidewalk pathway network where concrete or asphalt repairs are warranted. Some repairs require or warrant concrete or asphalt removal / reconstruction, asphalt chip seal or grind and overlay. See photos ##40, #41 and #42. Path repairs should be classified as follows:

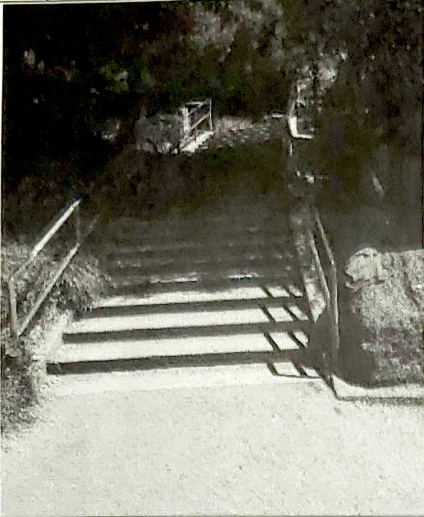
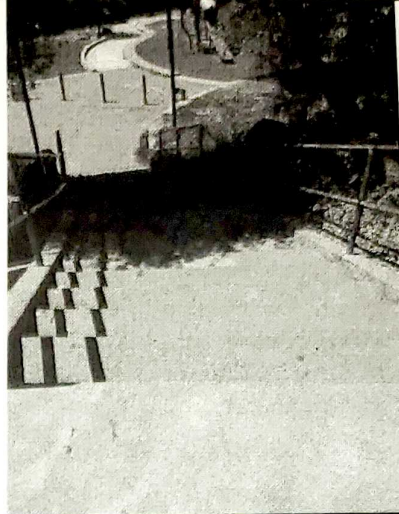
43. Existing staircase adjacent to rec center requires painted contrasting stair treads.

44. Existing staircase adjacent to rec center requires painted contrasting stair treads.

5. The staircase adjacent to the recreation center needs contrasting treads and should be evaluated for a center handrail. See photos #43 and #44.
6. The staircase from the upper recreation center near the two existing disabled parking stalls down to the center of the park should be evaluated. Stair repairs, contrasting treads and pavement repairs are needed. See photos #45 and #46.

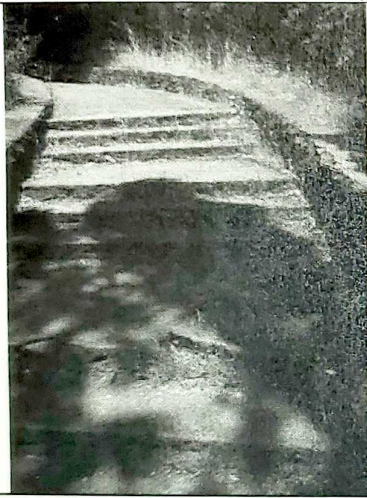
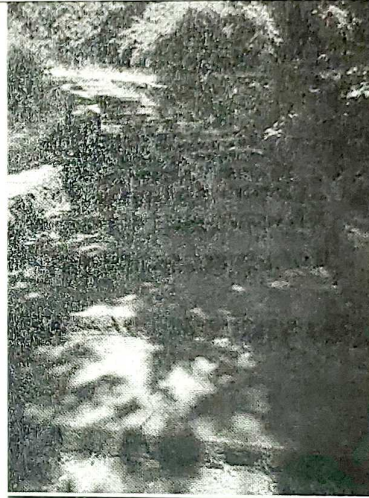
45. Staircase connecting the upper recreation center to the central area of park.

46. Staircase connecting upper parking lot to front of recreation center.

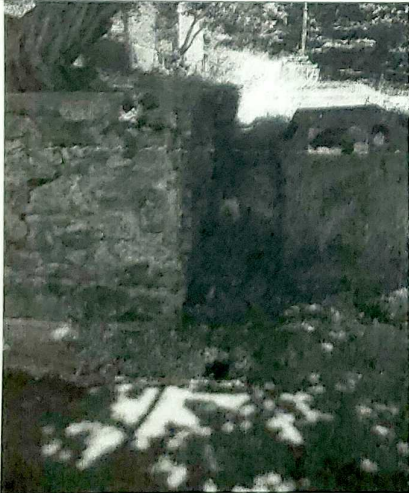
47. Existing drainage systems are in need of maintenance and repairs.

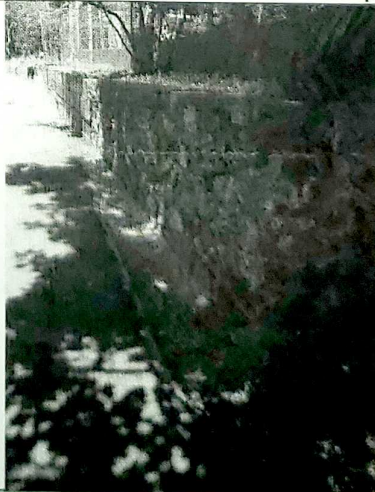
48. Existing drainage systems and walls are in need of maintenance and repairs.
